# PANHANDLE HEALTH DISTRICT I

At EPA's request an inspection of the Arrcom site was made on April 29, 1983 to determine the current condition of the tanks located at this site. Following is the results of that inspection. Please refer to the attached site plan for tank location and discriptions.

WASTE OIL PROCESSING PLANT  
 DREXLER ENTERPRISES INC.  
 RATHDRUM, IDAHO  
 SCALE: 1"=25'

RCRA VIOLATION ASSESSMENT

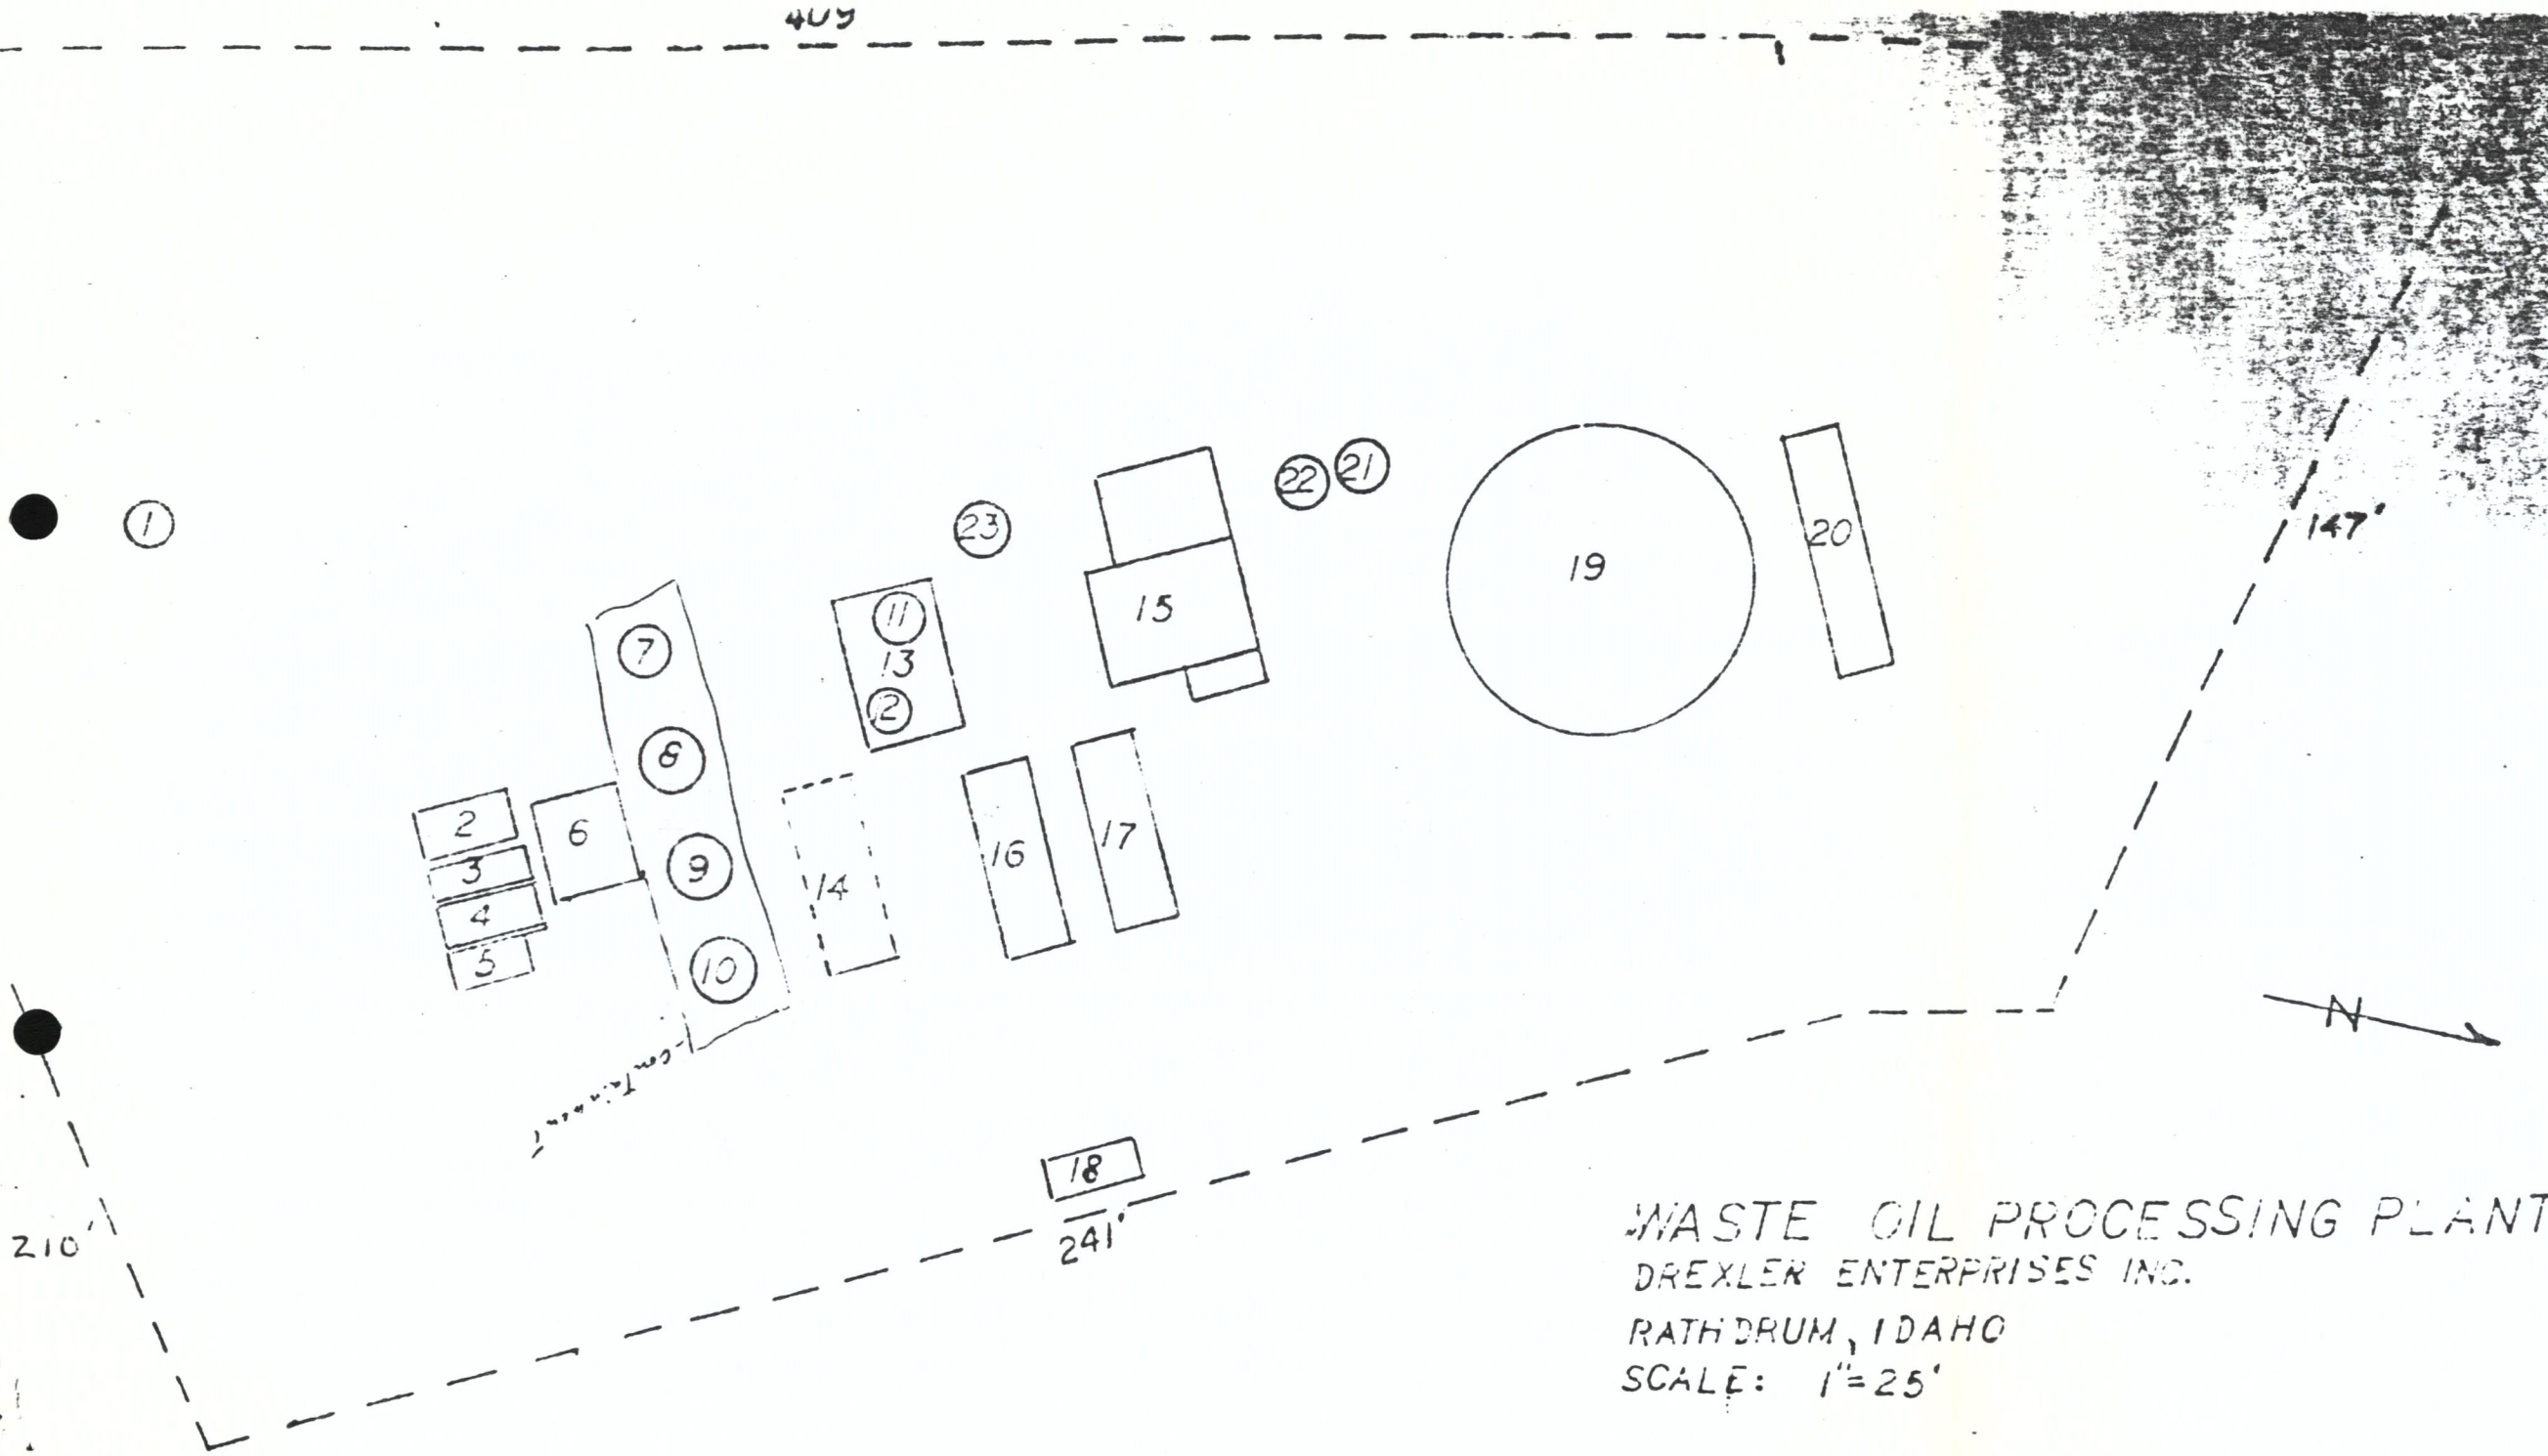
Tanks 2,3,4, and 5: These tanks appeared to be empty and in sound physical condition.

Tank 7: This tank had a small oil stained and oil built up area (approx. 4" x 10") at the bottom of one side of the tank. This could represent a small leak in the bottom of this tank. There was also some seepage from piping entering tank 7. This tank was about 3/4 full.

Tanks 8 and 9: These tanks appeared to be sound but did have some seepage from piping between these tanks.

Tank 10: There was a small amount of seepage around the outlet valve of Tank 10.

Tank 14: This tank is buried and the condition is not known.

Tank 16: This tank appeared to be sound and had no signs of leakage.

Tank 17: Tank 17 appeared to be sound and had no signs of leakage from the tank. There was a small drip from a coupling leading to tank 17.

Tank 11: This tank appeared to be sound and not leaking. However, there was a small drip from a pump located in building 13.

Tank 23: Ground around this tank is oil stained. However, the tank itself appears to be sound with no signs of leakage.

Tanks 21 and 22: These tanks are not connected and appeared to be empty. The area between building 15 and tank 19 and around tanks 21 and 22 is heavily oil stained.

Tank 19: This is a bolted seamed tank and many of the seams in the lower 2 feet of the tank were wet (not dripping) indicating some incomplete gasket sealing. The tank itself appears sound.

Tank 20: This tank appears to be sound and showed no signs of leakage.

In general, the condition of the site appears to be about the same as the last inspection. The tanks seem to be structurally sound with most of the seepage being from valves or pipe couplings. This inspection was an external visual inspection of the tanks, so the volumes and internal condition of the tanks is not known.
